Docket No. 217 – Development and Management Plan Inspection

Northeast Utilities Service Company Certificate of Environmental Compatibility and Public Need for the construction of a 345-kV electric transmission line and reconstruction of an existing 115-kV electric transmission line between Connecticut Light and Power Company's Plumtree Substation in Bethel, through the towns of Redding, Weston, and Wilton, and to the Norwalk Substation in Norwalk, Connecticut.

Date: January 4, 2005

Location: 345kV XLPE Component

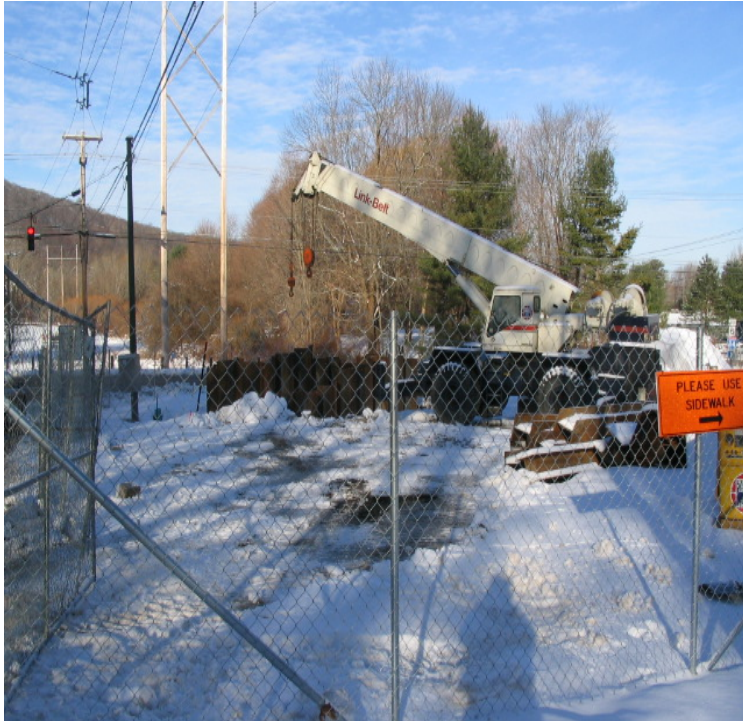
345kV XLPE (Jack and Bore): Photo on the left is an overall view of the site with excavation underway and continued work on the bore pit. Photo on the right is looking towards the covered stockpile. 1/04/06

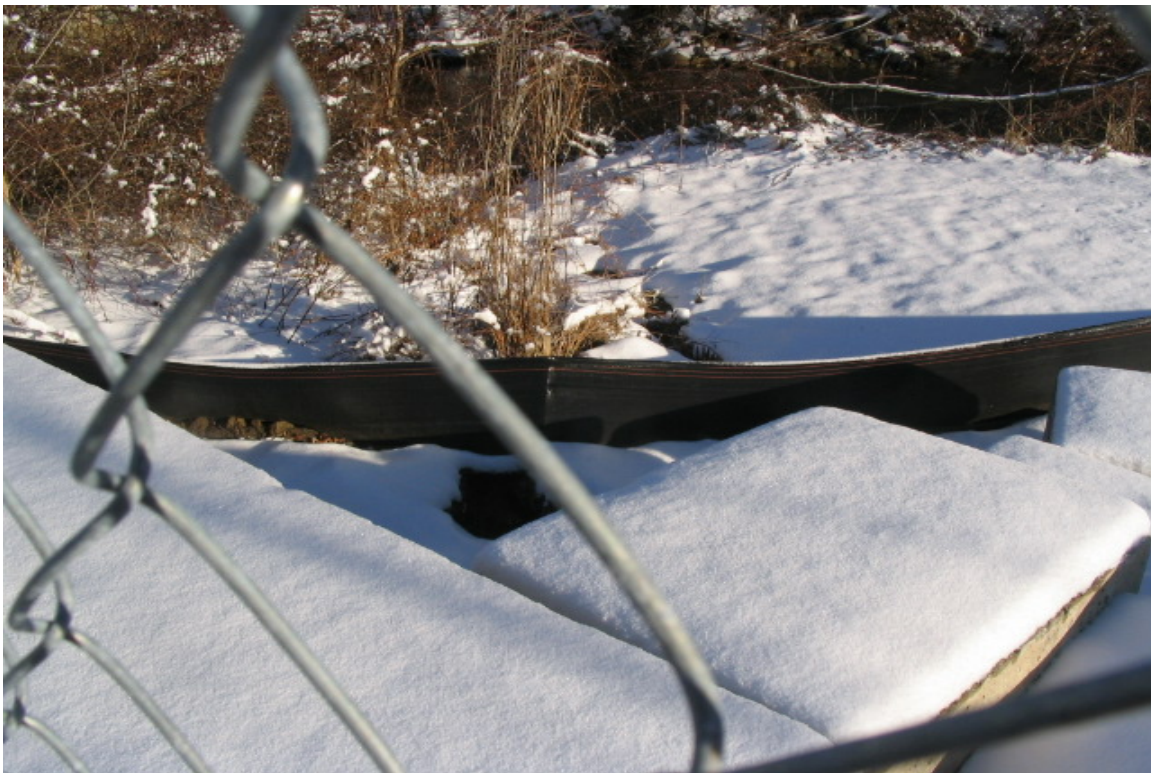
View of the silt fence downgradient of the site and near the river. Some natural run-off has created a small gap under the fence. 1/04/06

Areas of Inspection	Observation	Recommended Action
Access Roads and Adjacent Roadways	<p>-The only component of this project currently active is the preparation for a jack and bore of East Swamp Brook located at the intersection of Plumtrees Rd. Walnut Hill Rd. and Whittlesey Dr. 11/23-1/4/06.</p> <p>- A pad has been constructed off Whittlesey and Plumtrees Rd. for the bore pit. 11/23-1/4/06</p>	-A stockpile remains in place in the vicinity of the road. An adjacent catch basin was noted and contractors were reminded to place controls here if necessary. 12/8-1/4/06.
Trench and foundation construction	- The site was fairly inactive at the time. The bore pit excavation and sheet piling/shoring is still present. 1/4/06	- The pad remains fairly well contained at this time and most snow cover has melted. 1/4/06.
Erosion and Sediment Controls (includes inspection within 24 hours of a storm event)	<p>-The stockpile on site remains and was covered with plastic to reduce run-off. The silt fence installed at the base of the pile needed some maintenance but snow cover had returned. 12/30-1/4/06</p> <p>- The silt fence adjacent to the river still appears to be well in place but natural run-off has created a small gap. 1/4/06</p>	<p>- Check the fence and toe in where necessary. If the fence cannot be toed-in, consider installing haybales or a berm. 1/4/06</p> <p>- Disturbed soil was noted but remains contained at this time.</p> <p>- Attempt to toe this spot back-in or place a haybale when snow cover melts. 1/4/06</p>
